Phytophthora Management Plan

Emerald Hills Estate residential development, Leppington, New South Wales (EPBC 2013/6999)

Prepared for Macarthur Developments Pty Ltd

November 2017

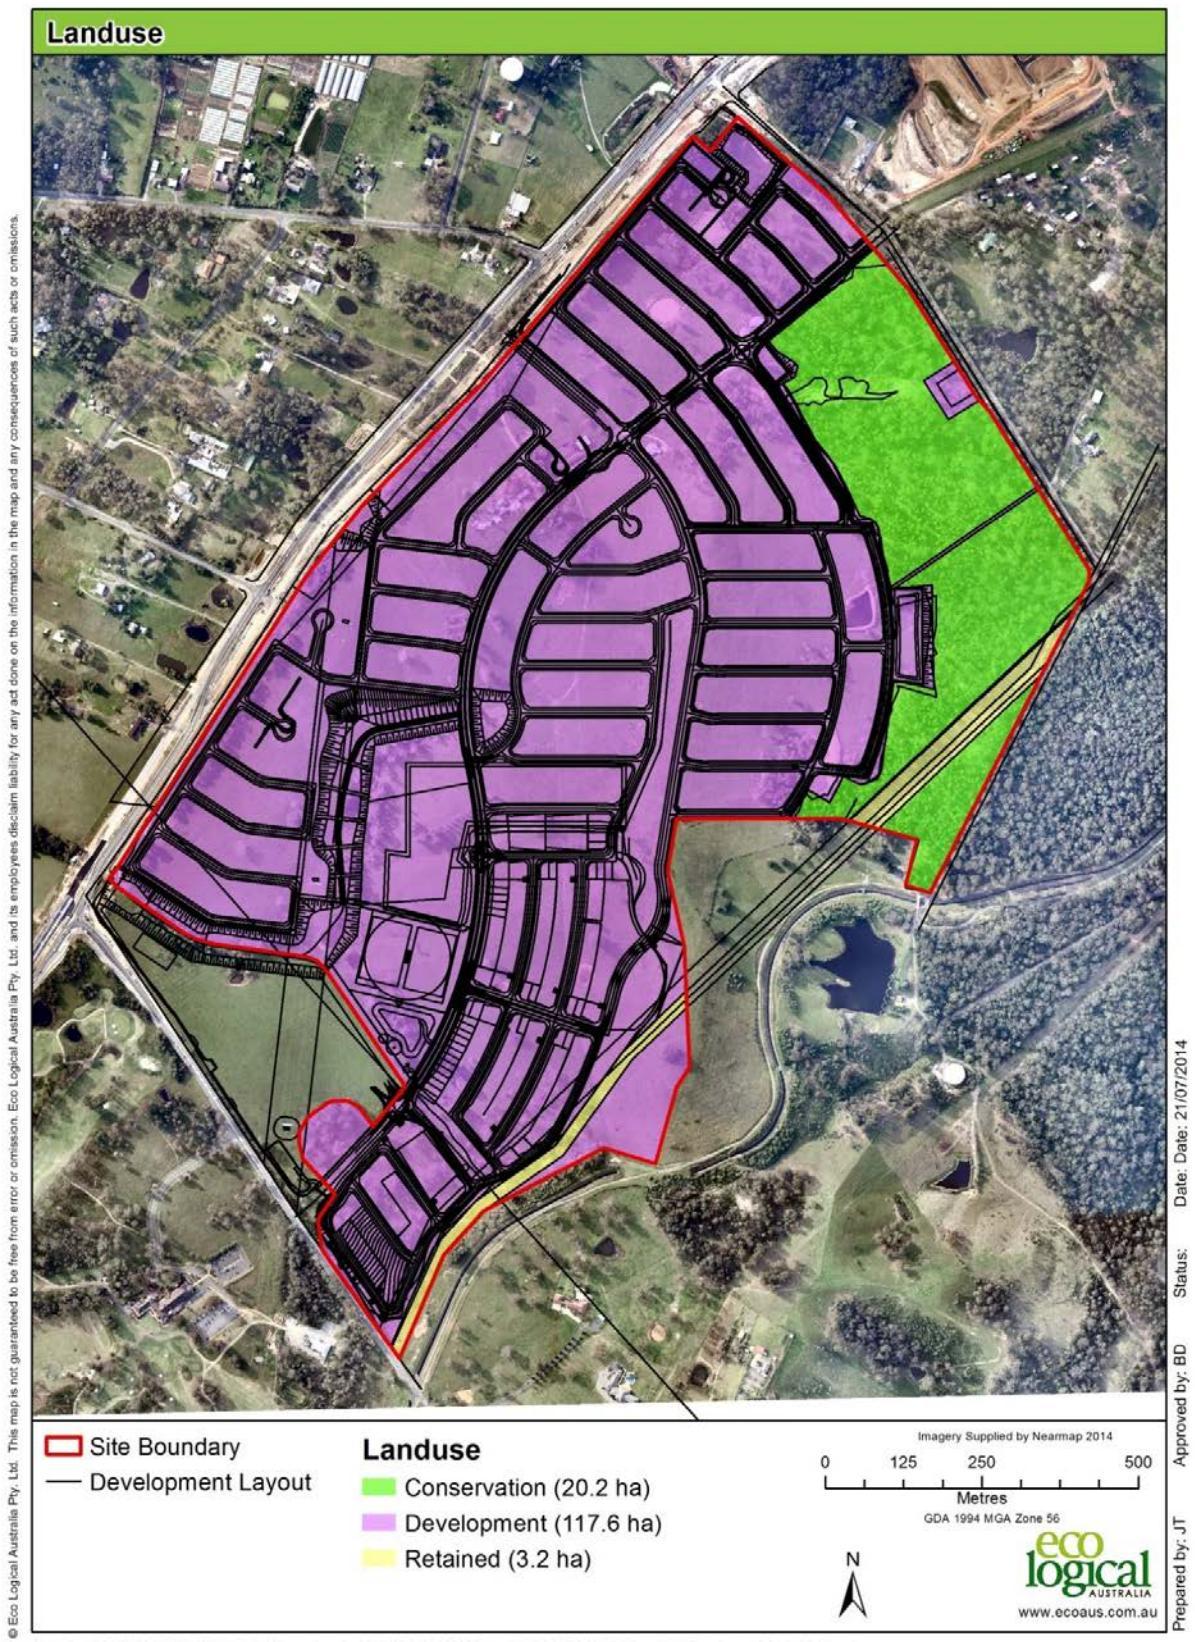
Figure 1: Development and Conservation Areas at EHE

The overall development will be for residential landuse and is planned to consist of residential dwellings, associated infrastructure, parkland and open space, and environmental conservation (**Figure 1**).
